OFFICER'S HOUSING TYPE 1D

CONDITION SURVEY DATA SHEET

CONDITION SURVEY

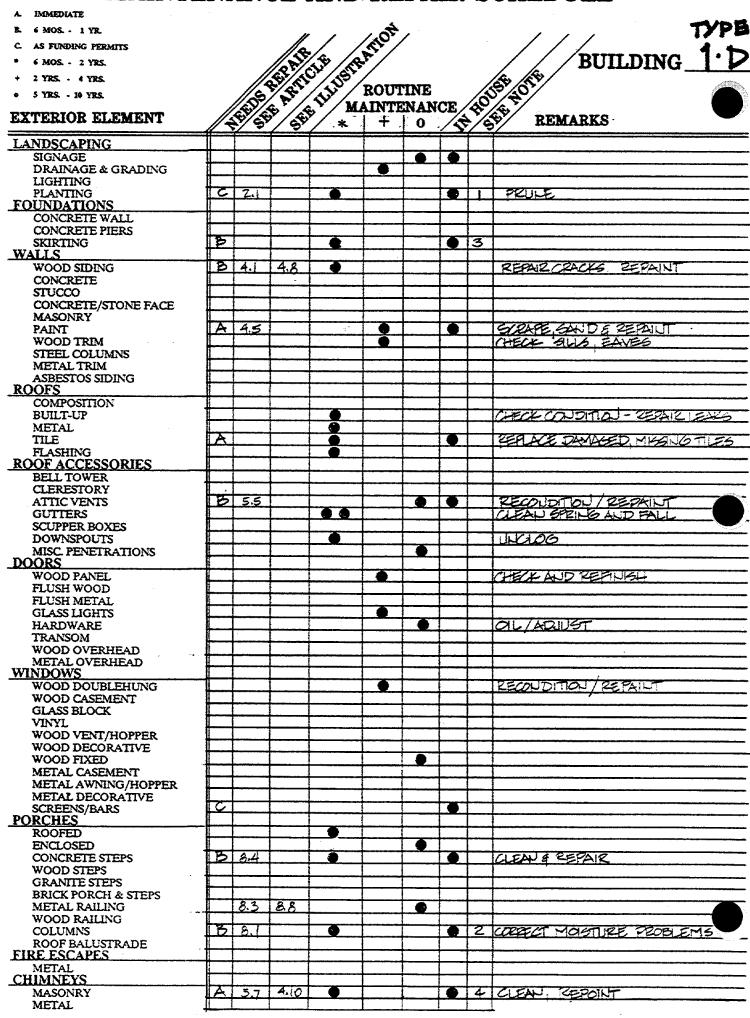
MAINTENANCE AND REPAIR SCHEDULE

- 1. Shrubs and trees too close to wall. This will accelerate deterioration of walls and windows and clog gutters.
- 2. Columns exhibit water damage at bases. Mitered plinth joints are opening. Stave joints beginning to separate.
- 3. Paint is peeling from lattice skirting, portions in contact with soil are rotting, some slats are missing.
- 4. Chimneys are soiled and mortar is in bad condition. Some need to be rebuilt where corbelling has broken off.

- a. Refer to article on "Planting and Pruning".
- b. Prune or remove shrubs and trees that are crowding building, or transplant to a location farther away from walls.

- a. Refer to article on "Wood Columns". Do repair work only when wood has had sufficient time to thoroughly dry.
- b. Small cracks can be caulked or filled with standard wood filler.
- c. Opening joints should be reglued and clamped tight until glue has set.

- a. Lower grade beneath lattice such that lattice is not in contact with soil or "landscape bark".
- b. Replace rotted or missing slats.
- c. Scrape and sand areas of loose paint. Prime and paint.

- a. Refer to article on "Chimneys".
- b. Clean masonry and scrape out all deteriorated mortar.
- c. Replicate original corbelling where existing has broken off or previously been removed.
- d. Match appearance, size, and color of original brick units and match color of mortar.
